## XStream GapGorilla

### Test Protocol

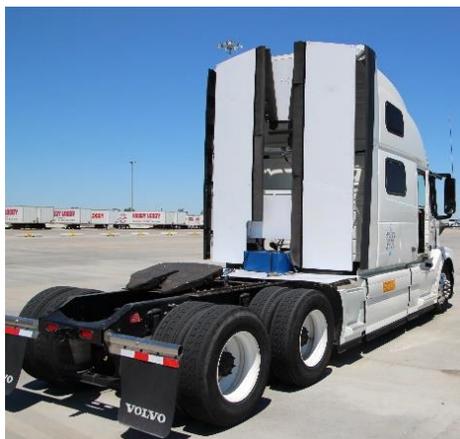
System stowed w/floor & blue fuel tank

The GapGorilla system was created to close the gap between the back of a highway tractor and the front edge of a trailer. The system is comprised of side extenders that reach from the existing OEM extenders to the front side edges of the trailer. A top portion lifts up and closes the gap from the top rear edge of the sleeper to the front edge of the top of the trailer. Additionally, a plastic floor replaces the deck plates above the frame rails behind the cab and covers the area from rear of the sleeper to the lower front edge of the trailer and all the way between the tractor chassis skirts on both sides of the tractor. In essence, the system nearly blocks out air flow in all directions between the tractor and trailer. The system automatically deploys at highway speeds, and automatically stows as the speed drops down from highway speeds.

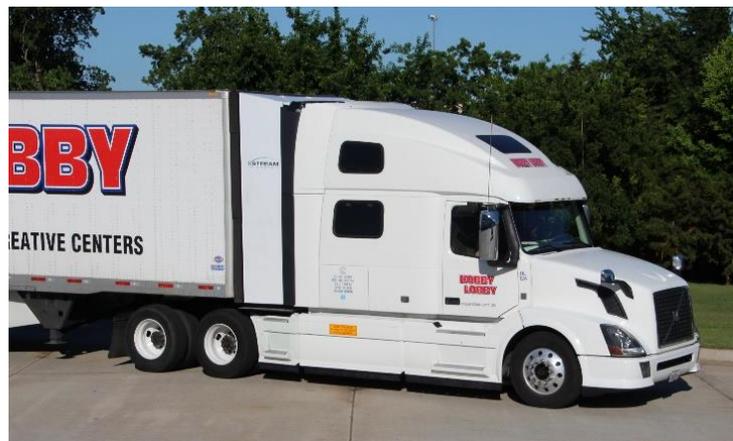
System deployed

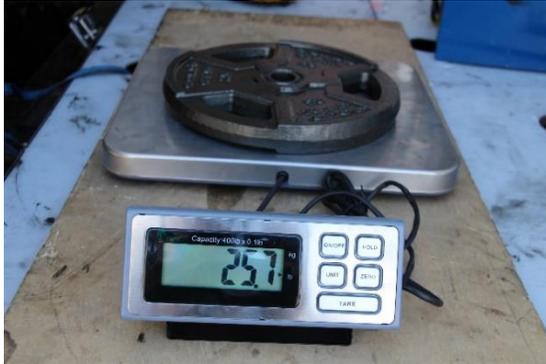
Test reference weight on scale

3. Weigh reference weight. Weigh tank & record (along with odometer and climate info). Weigh reference weight. If the reference weight did not match prior readings, the process of weighing started over again.

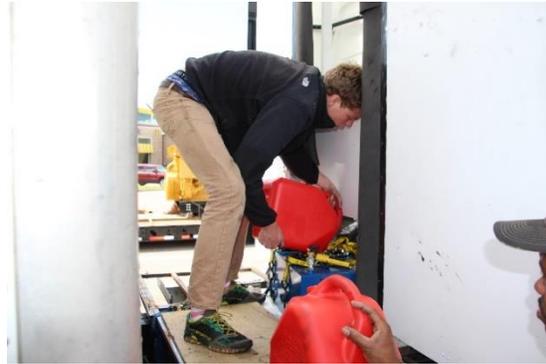
Filling the 20-gallon test tank

1. Roughly 40-mile warm-up trip from Hobby Lobby shop to starting point.
2. Once at the starting point, the test fuel tank was disconnected via quick connect fittings. The test tank was filled near to its top from diesel fuel fill containers.

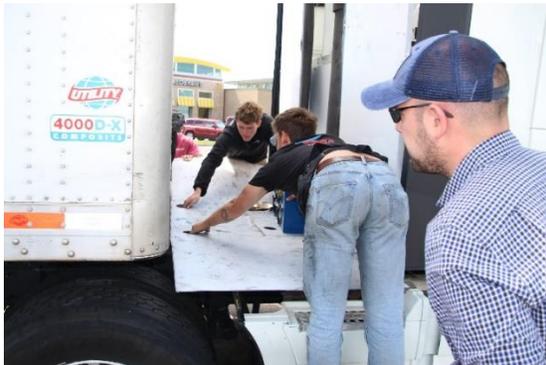
Installing the GapGorilla floor between runs

4. Reconnect fuel lines and secure test tank in place.
5. Make modifications as required. To switch to the deployed runs, the floor was added back above the frame rail and secured with nuts. The D shaped surface was added back to the top of the GapGorilla. When going back to the reference configuration, the floor and D surface were removed.

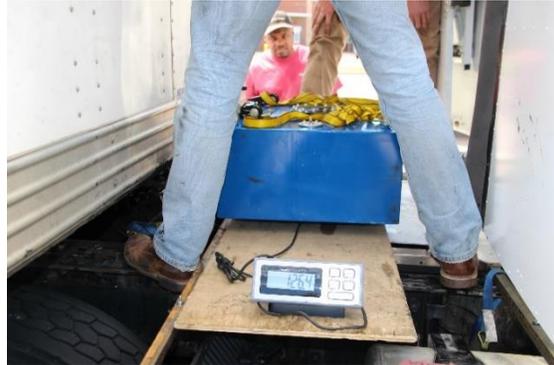
Weighing the test tank (no floor on this run)

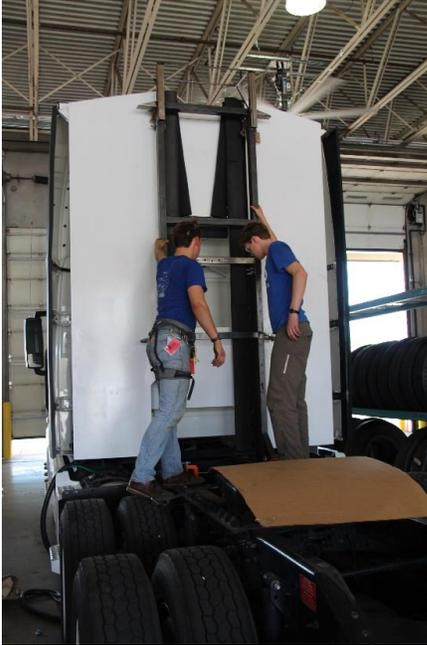
System installation with ladder rig

The XStream employees installed the components of their GapGorilla system to the back of the sleeper cab of a Volvo tractor owned by Hobby Lobby. A climbing frame was attached to the frame to serve as an installation platform. Part of the team scouted the area's interstates to find a long section that did not have any construction zones or other potential delays.

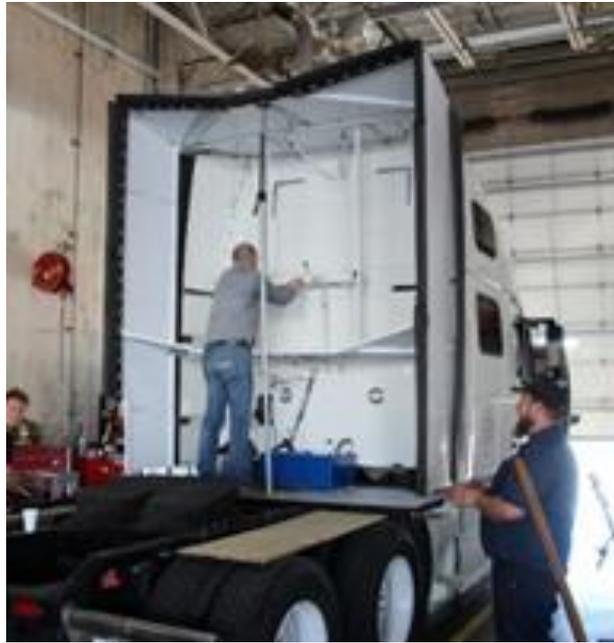
Installing actuator with system deployed

The main actuator was installed along with wiring to the cab to the control system. All systems were tested in the garage before taking the tractor out to the lot and validating functionality. The deploy and stow speeds were lowered in the control software to allow low speed test runs. Additional runs were made to record the system visually.
